Washington State Department of Ecology Hazardous Waste and Toxics Reduction Program

RCRA Site ID: WAH000050091	Facility Name: Treoil Industries	Inspection Date: March 6, 2017
Generator Status: LQG	Facility Address: 4242 Aldergrove Rd., Ferndale WA 98248	Date Report Sent:

PHOTO LOG

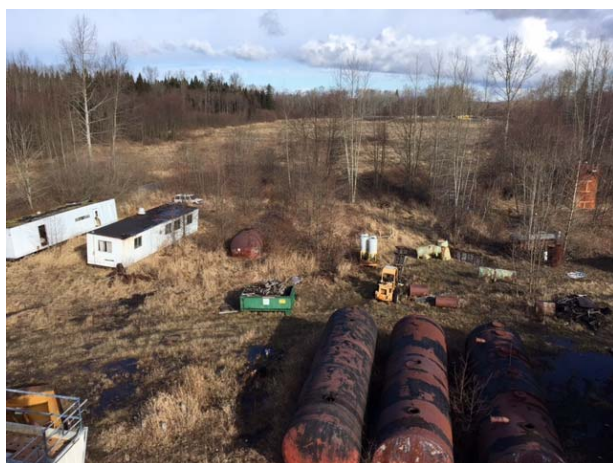
Another view of area to the north of the tank farm.

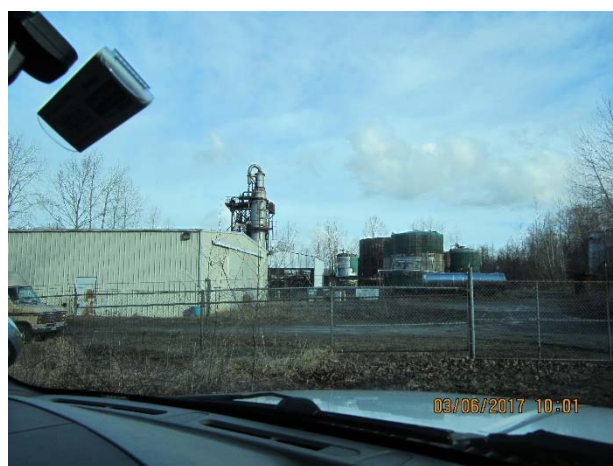
#8 Treoil Property Entrance

View to the north from outside the entrance gate.

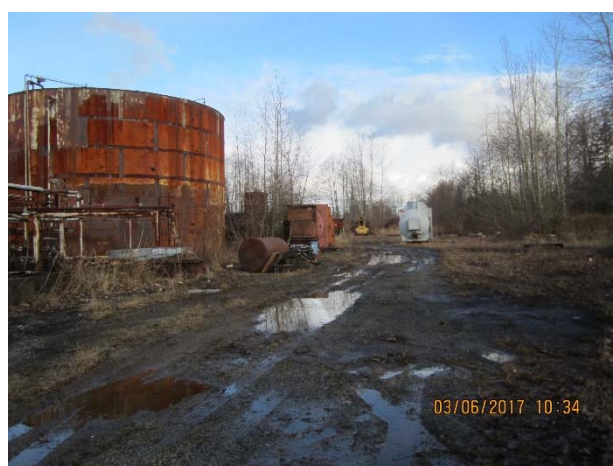
#10 East of Tanks

Looking north.

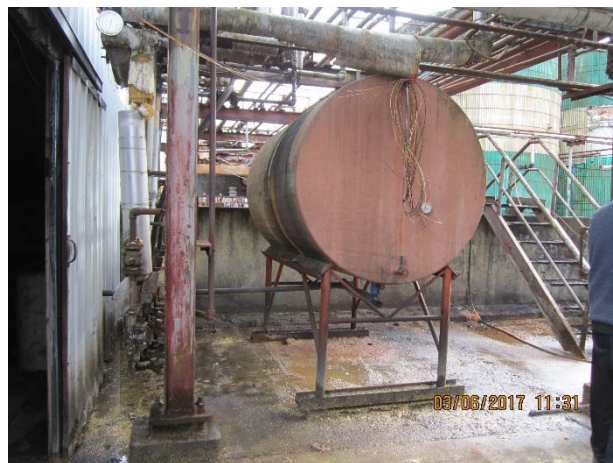
#19 Central Pad, Outside West Wall of Tank Containment

Heating oil tank for boiler located inside small building to the left.

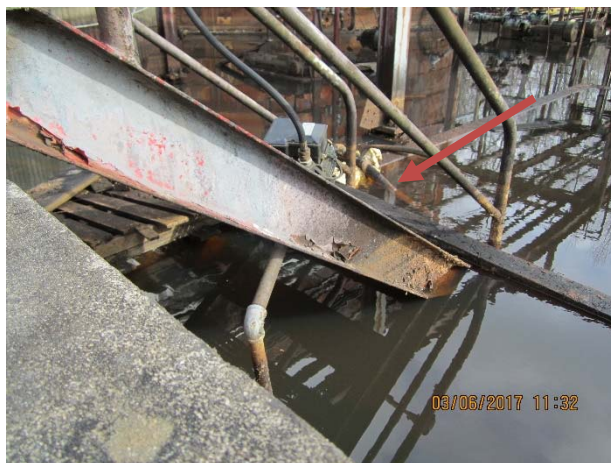
#22 Tank Farm Containment

Hose in containment, actively discharging water to concrete pad below. Hose placed onto scaffold (?) during inspection.

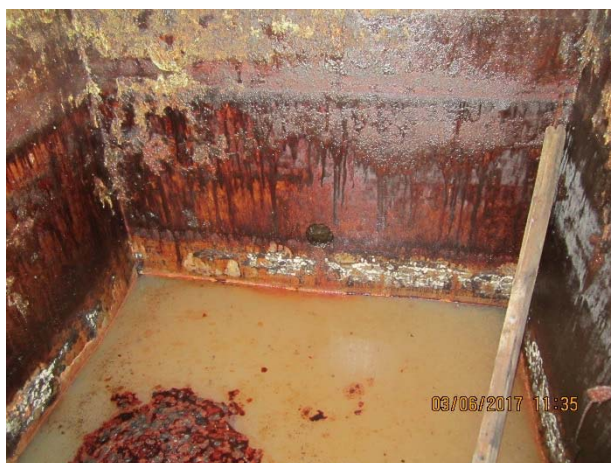
#27 Central Pad, Under Partial Roof

The lid on this rectangular steel container was removed to observe an oily solution within. The pH of this solution was not determined.

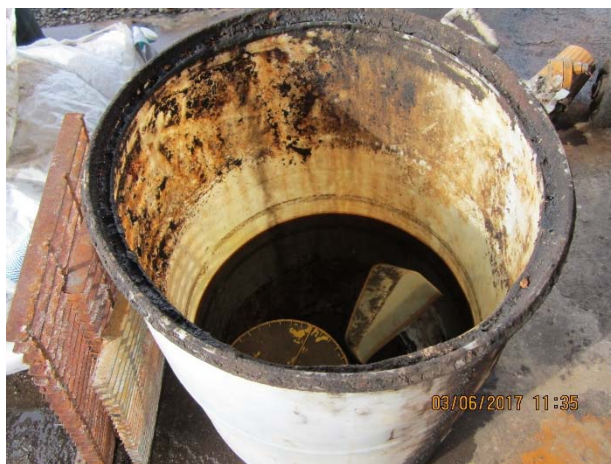
#28 Central Pad, Under Partial Roof

This open plastic drum contained what appeared to be motor oil but could have been tall oil.

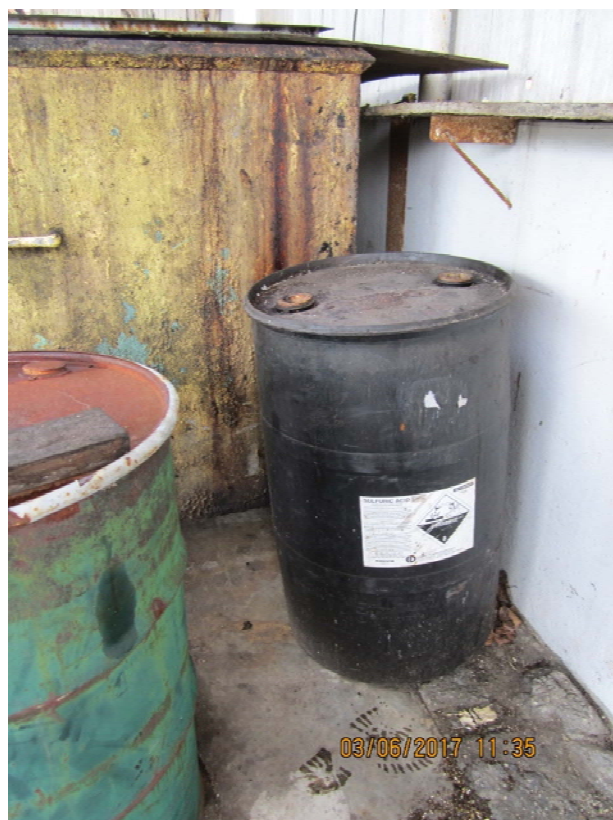
#29 Central Pad, Under Partial Roof

This black poly drum, labeled “Sulfuric Acid,” felt nearly empty.

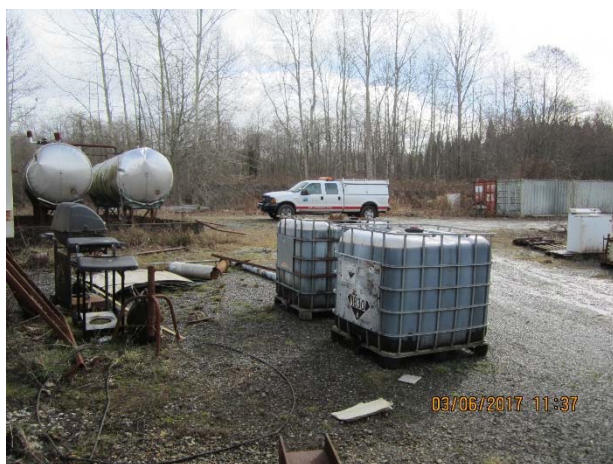
#30 Graveled Area South of Central Pad

These totes contain glycerin scheduled to be removed by Whole Energy Wednesday, March 8 (4 total).

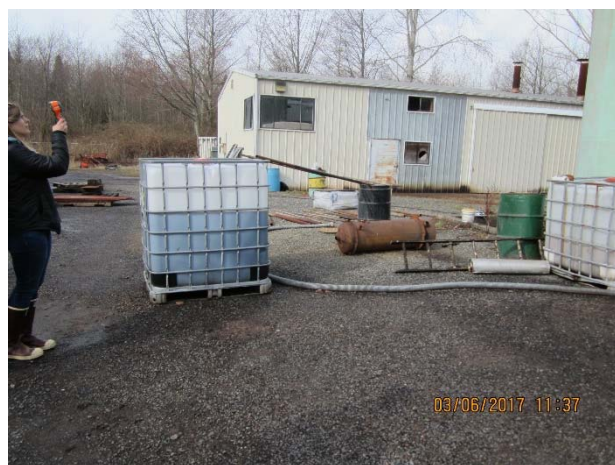
#31 Graveled Area South of Central Pad

The tote to the left contains glycerin, scheduled for removal March 7. The tote to the right is empty. In the background of this photo is a 20' X 30' warehouse (north-south oriented).

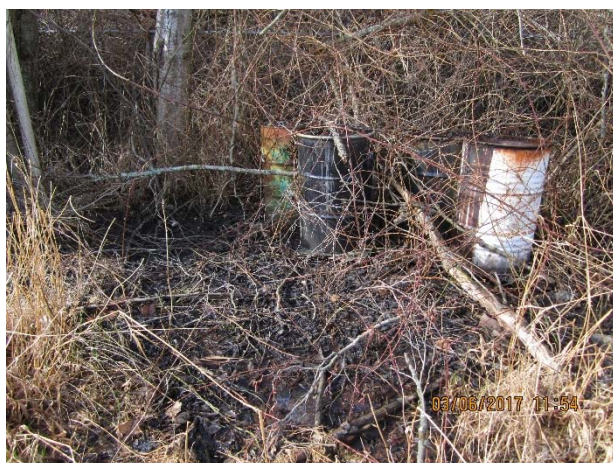
#42 West Fence-line

Four 55-gallon drums located south of conex container along west fence-line. One drum was open and empty while three felt full and were closed. None were labeled.

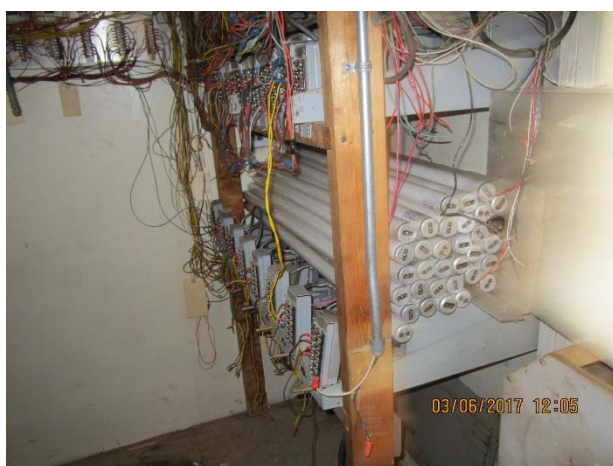
#45 North – South Warehouse

Universal waste lamps upstairs in electrical room.

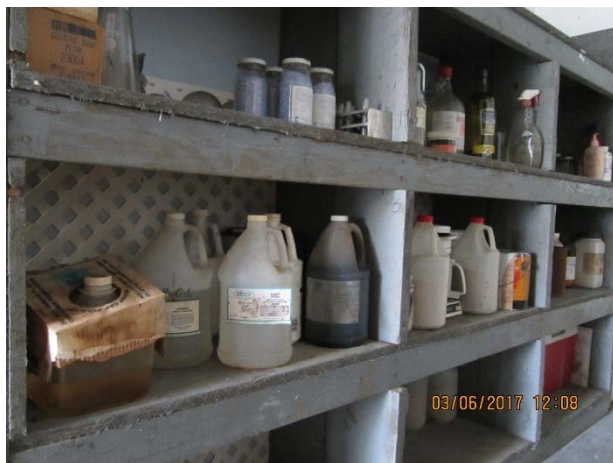
#46 North – South Warehouse

Chemicals from former lab located in this building. Visible in this photo are glacial acetic acid and unknown oils.

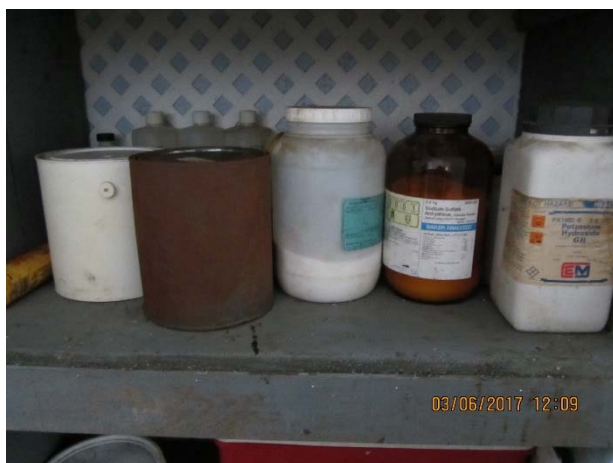
#47 North – South Warehouse

Visible in this photo are anhydrous sodium sulfate and potassium hydroxide. Other containers were not disturbed for the purpose of reading labels.

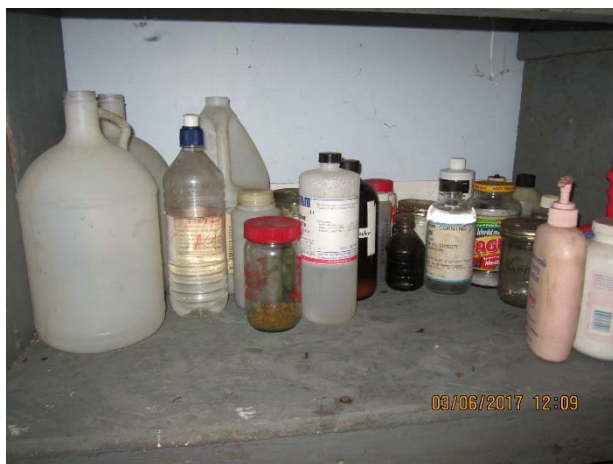
#48 North – South Warehouse

More lab chemicals, including "citric acid," potassium hydroxide, and others containers not disturbed to read labels.

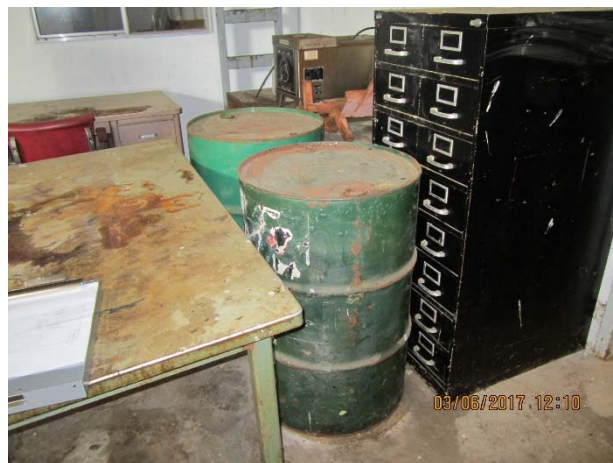
#49 North – South Warehouse

One of two green 55-gallon drums was empty.
One was very heavy. Contents unknown.

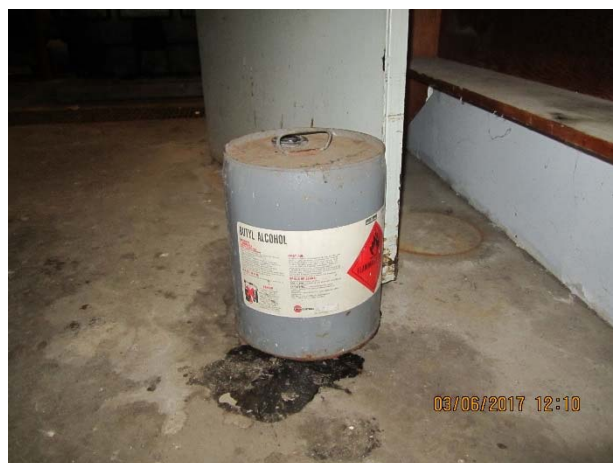
#50 North – South Warehouse

This five-gallon gallon of butyl alcohol was
being used as a door stop.

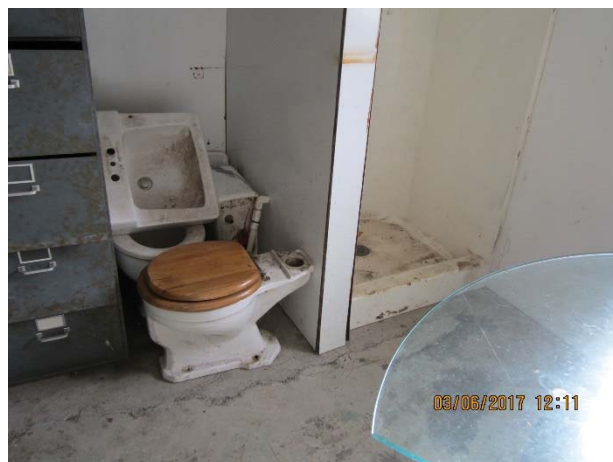
#51 East - West Warehouse

Bathroom photographed to indicate connection
to on-site septic system.

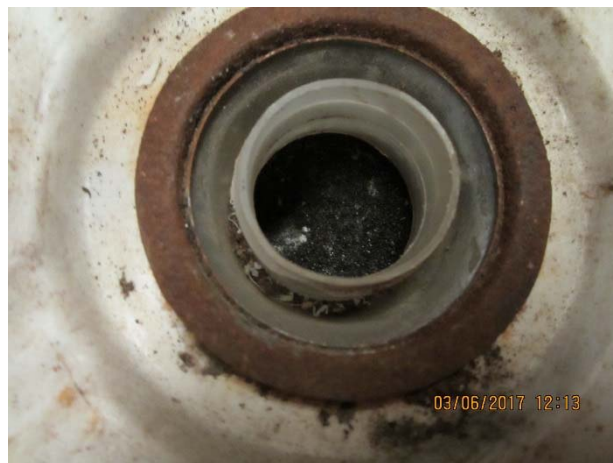
#52 East – West Warehouse

Looking into an open hole in the lid of one of the “soy sauce” containers shown in photo 53.

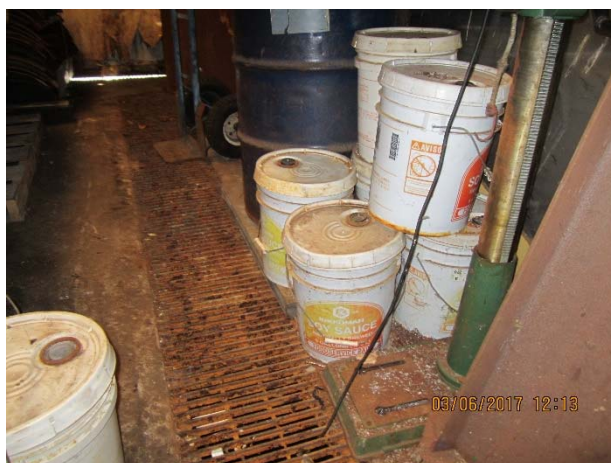
#53 East – West Warehouse

“Soy sauce” buckets with unknown contents. The blue drum seen in this photo is not labeled. Several inches of water visible in floor trench drain.

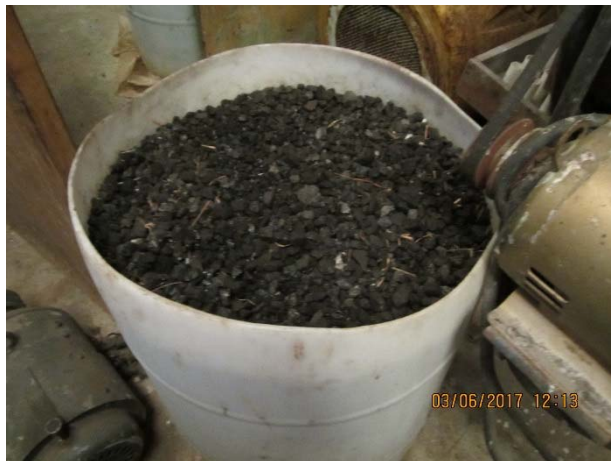
#55 East – West Warehouse

This material had the appearance of shiny black rock.

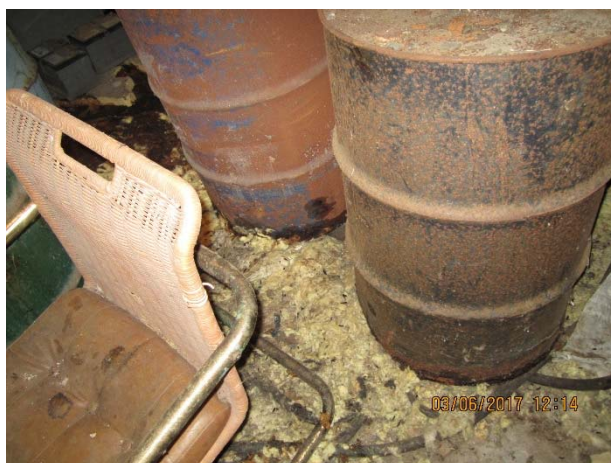
#56 East – West Warehouse

Unknown substance (insulation?) on floor surrounds these drums with unknown contents.

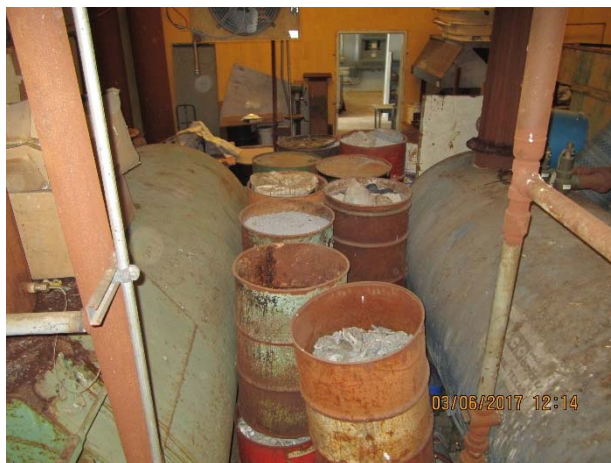
#58 East – West Warehouse

Sandy and gravelly material within drums could have been used grit, ash from a furnace, or refractory materials.

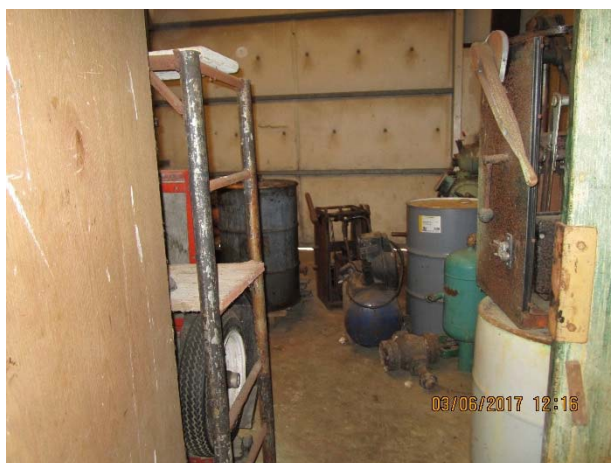
#59 East – West Warehouse

More drums with unknown contents.

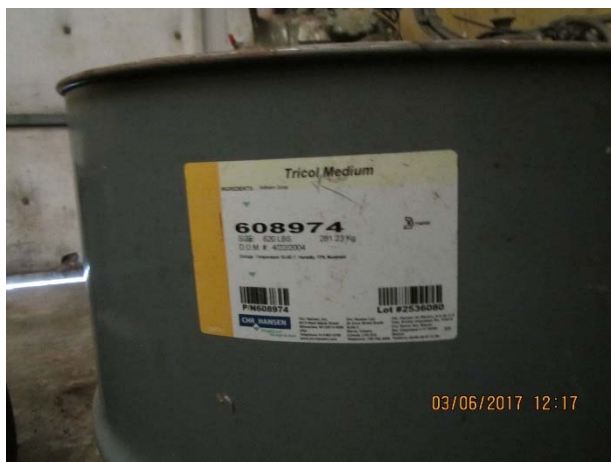
#60 East – West Warehouse

Closed 55-gallon drum labeled “Tricol Medium.”

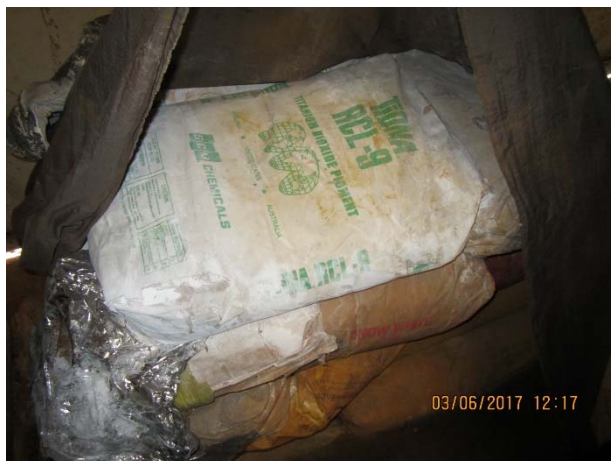
#61 East – West Warehouse

Numerous bags of titanium dioxide pigment.

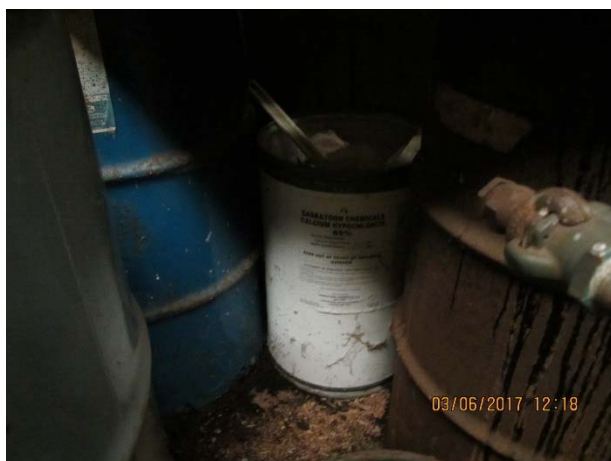
#62 East – West Warehouse

Smaller drum labeled “Calcium hypochlorite 65%.” Other drums have unknown contents.

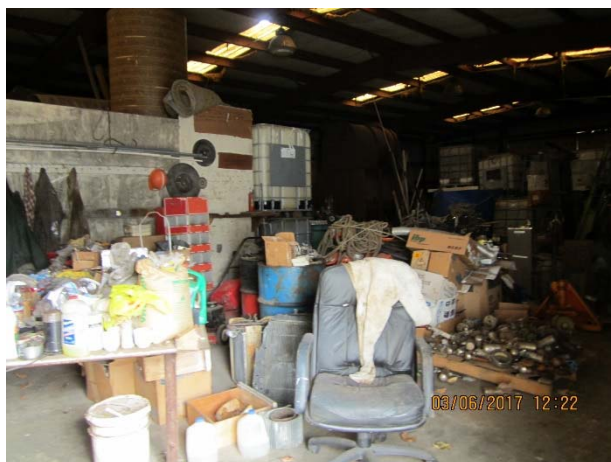
#63 East – West Warehouse

View of warehouse from entrance.

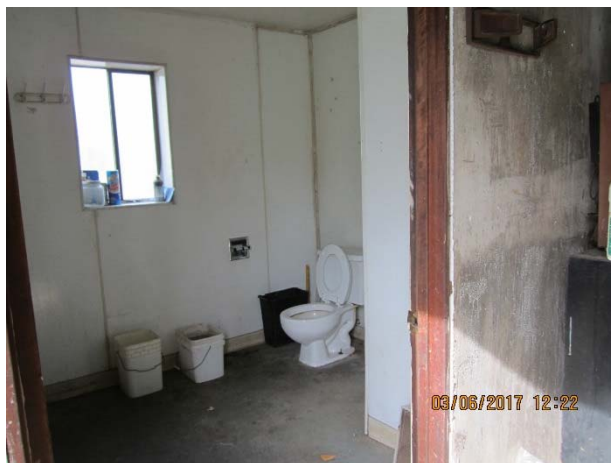
#64 East – West Warehouse

Bathroom noted in warehouse.

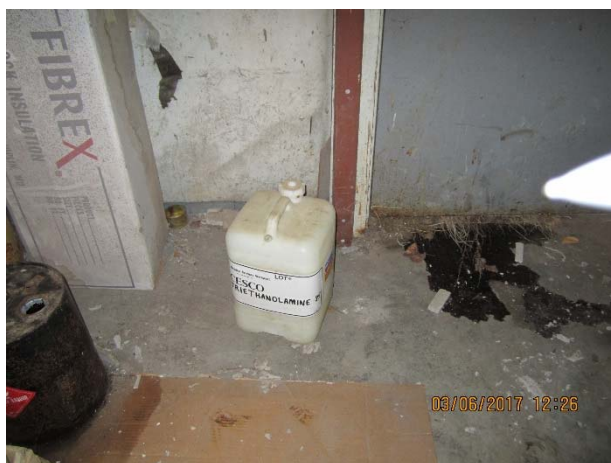
#65 East – West Warehouse

Triethanolamine, 5 gallons.

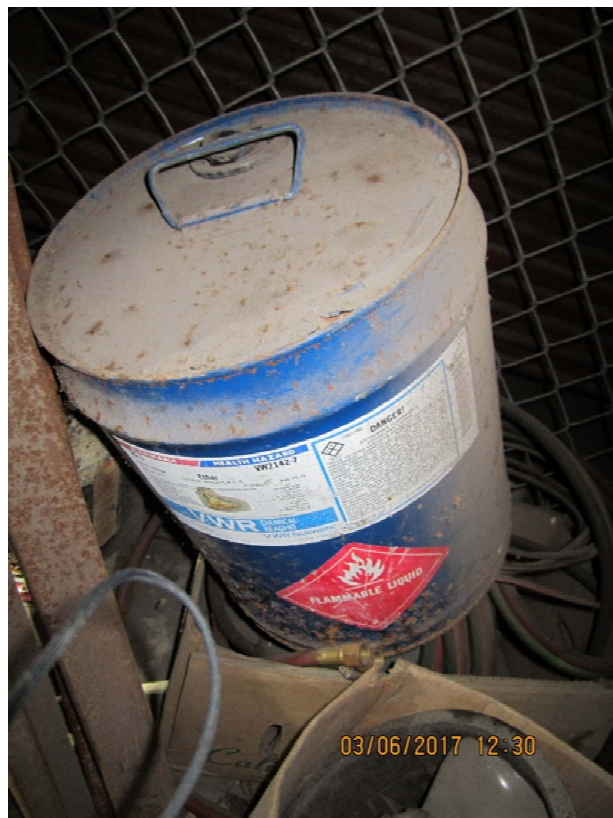
#70 East – West Warehouse

A five-gallon can of ether, found in the caged area long the north wall of the warehouse.

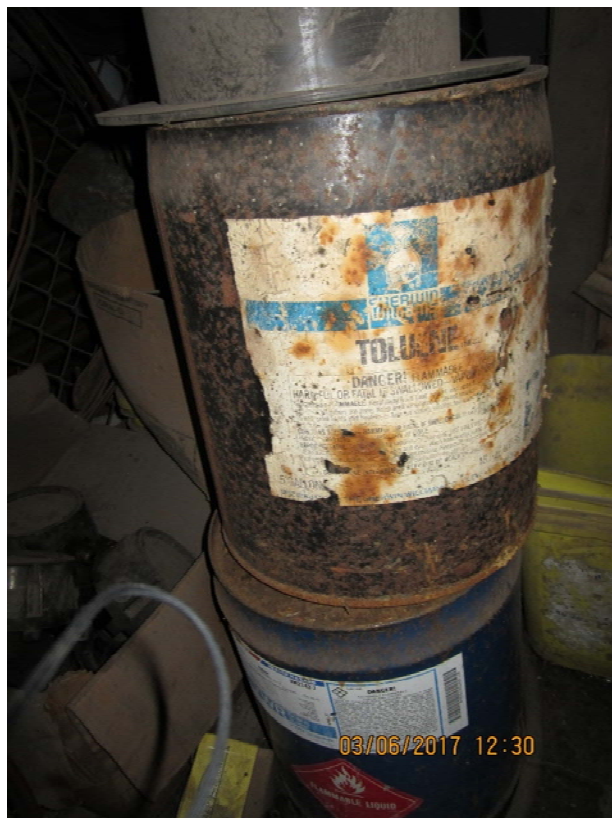
#71 East – West Warehouse

A five gallon container of ether and a five-gallon container of toluene found stacked in the open “cage” along the north wall of the warehouse.

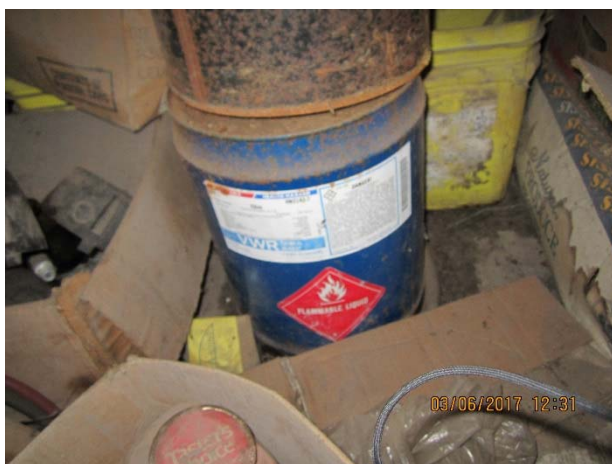
#72 East – West Warehouse

Close up picture of ether shown in photo 71.

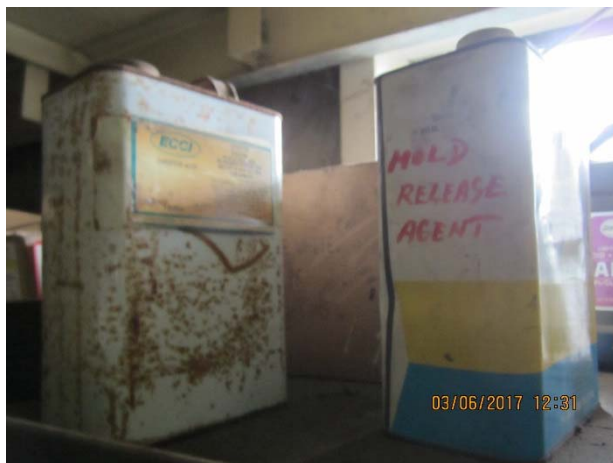
#73 East – West Warehouse

Chemicals found in caged area along north wall of warehouse. The “mold release agent” can was also labeled “xylol.” The other can’s label is illegible in this photo, and not noted during the inspection.

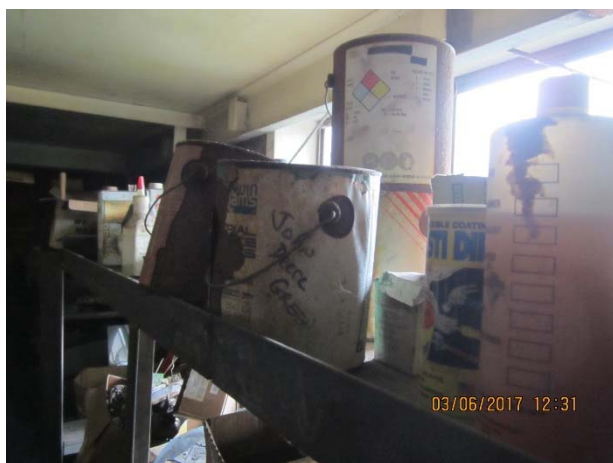
#74 East – West Warehouse

Paint cans and unknowns found in caged area along north wall of warehouse.

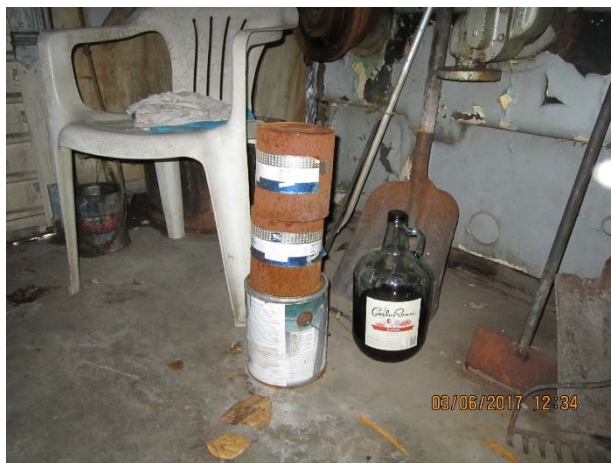
#76 East – West Warehouse

Paint cans with unknown contents.

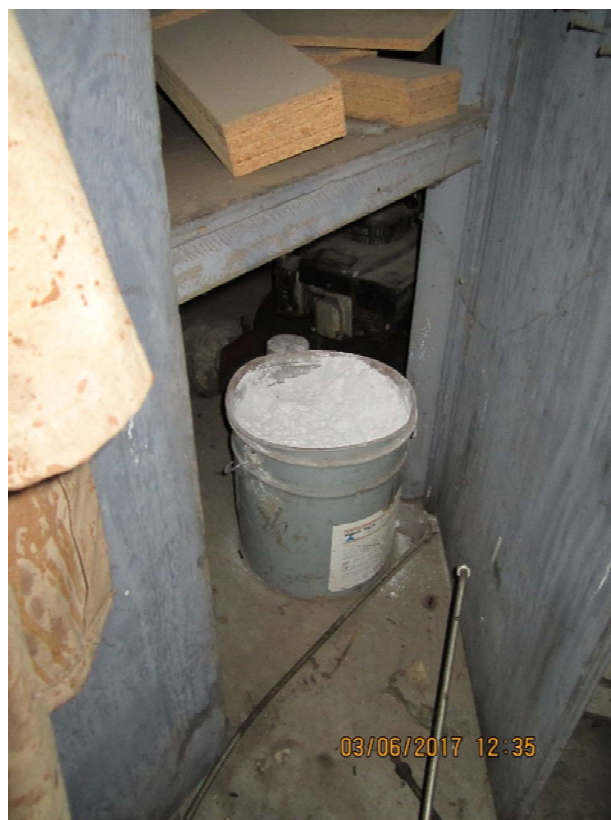
#77 East – West Warehouse

Unknown powdery substance in open bucket.

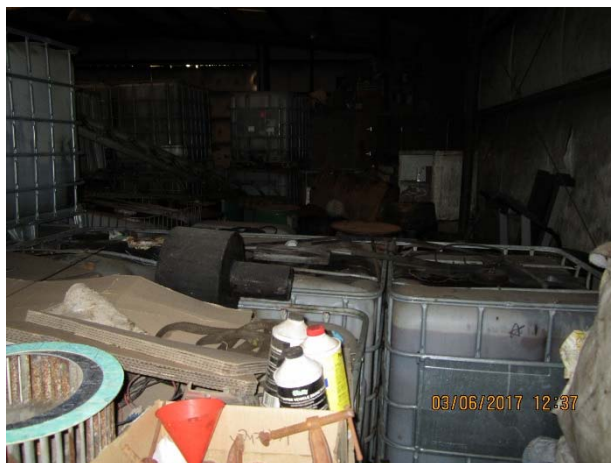
#78 East – West Warehouse

Empty and partially full totes and other debris within warehouse. Some of the empty and nearly empty ones (estimated 40) to be removed by Whole Energy Wednesday, March 8.

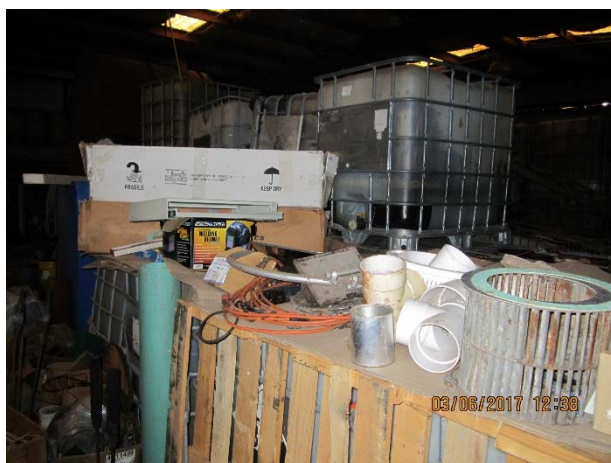
#79 East – West Warehouse

View from entrance looking north.

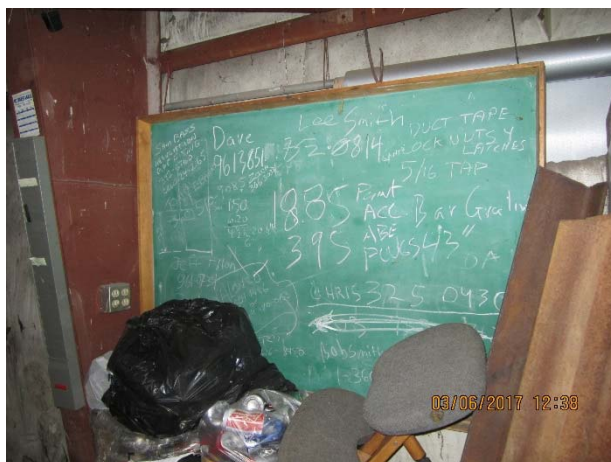
#80 East – West Warehouse

Chalk board in warehouse with possible site contact information.

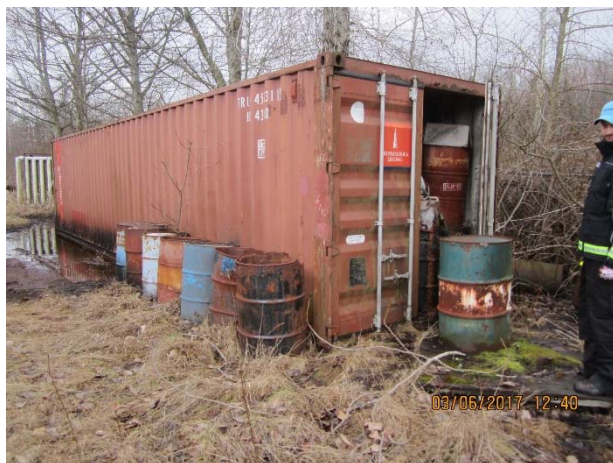
#81 Conex Container – Along Western Fence

Contents unknown, though said to be mostly vegetable fats for biodiesel production in the past (per Mr. Gill).

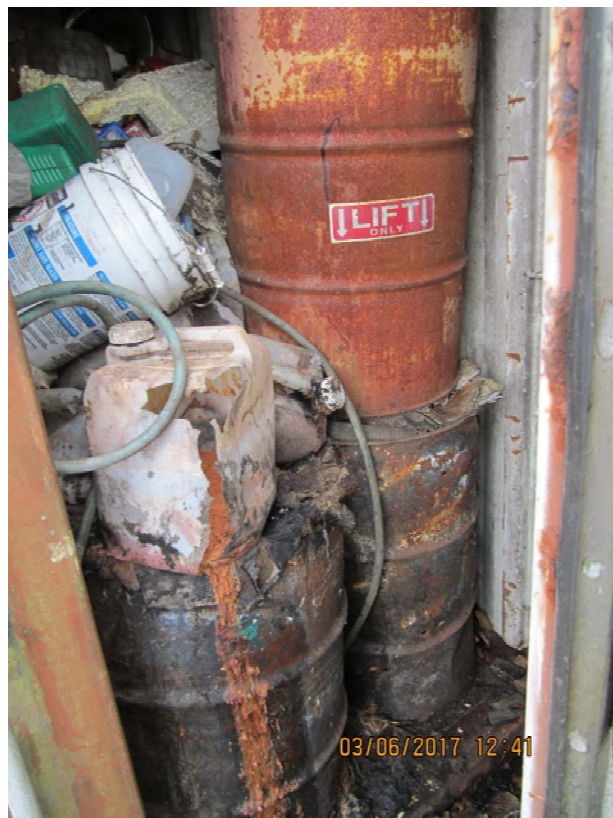
#83 Conex Container – Along Western Fence

Drums with unknown (vegetable fats?) content, and debris, within conex container.

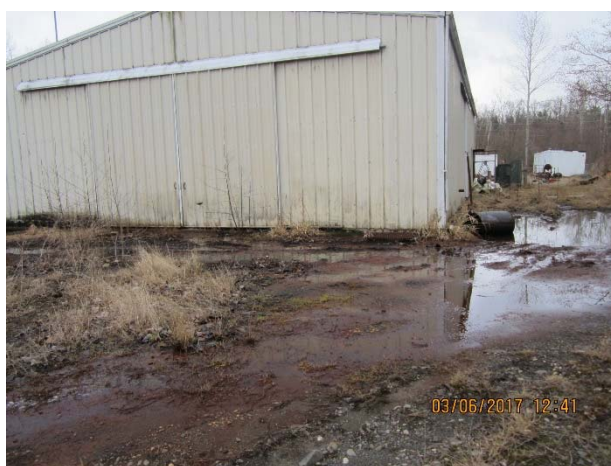
#84 North-South Warehouse

View from north looking south. The NW corner of the building is the location of one of the open pits, or drains, now not draining and full of oily water and debris.

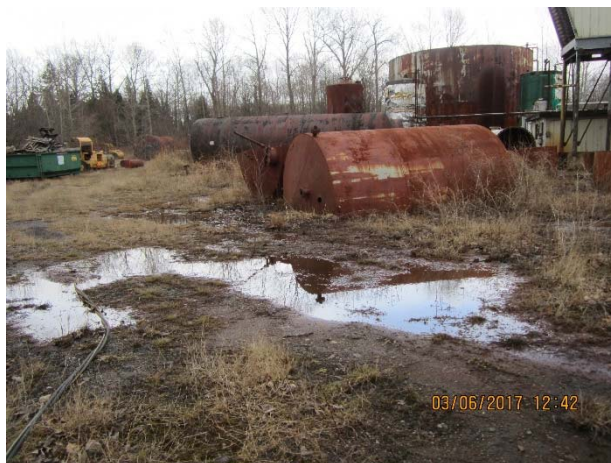
#85 North of North-South Warehouse

View to the east.

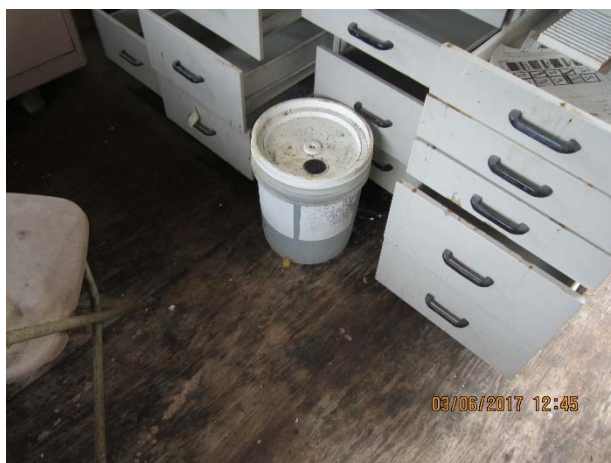
#86 North of Industrial Plant

Glycerin in lab trailer.

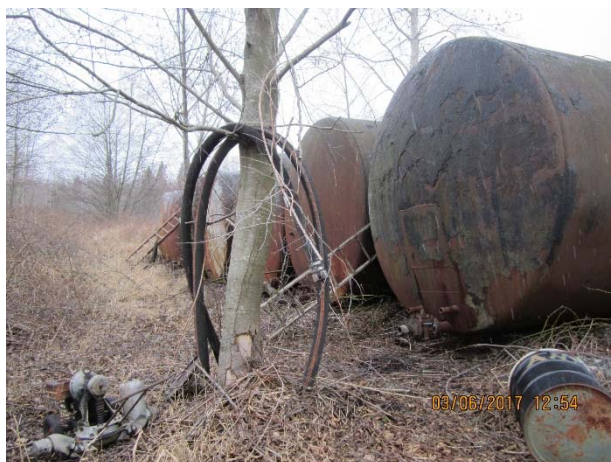
#87 North of Industrial Plant

Five of seven tanks lying on their sides, north of the industrial plant. These tanks appeared to have contents (knocking). The vegetation around these tanks was notably different from surrounding vegetation.

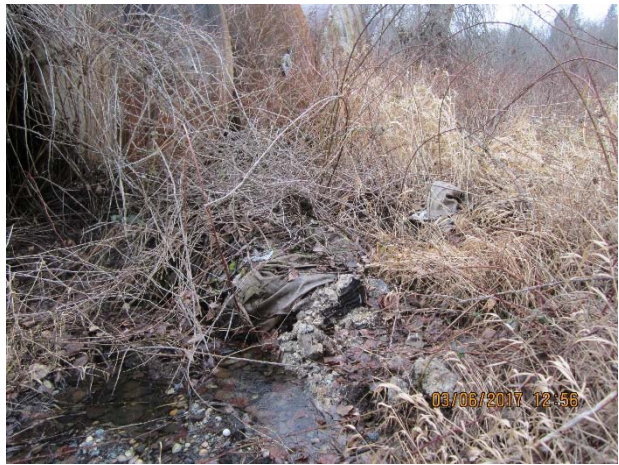
<p>#88 North of Industrial Plant</p> <p>Unknown substance on ground (rosin?).</p>

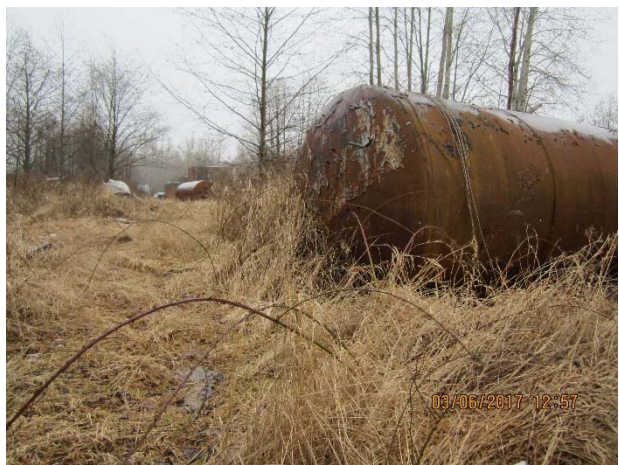
<p>A close-up photograph of a rusted metal tank. A dark, irregular substance is visible on the ground. A timestamp in the bottom right corner reads "03/06/2017 12:57".</p>
<p>#90 North of Industrial Plant</p> <p>Another view of tank shown in photo 89.</p>

End of tank shown in photos 89 and 90. Note that the port is plugged with wood, and contents appear to have leaked onto the ground.

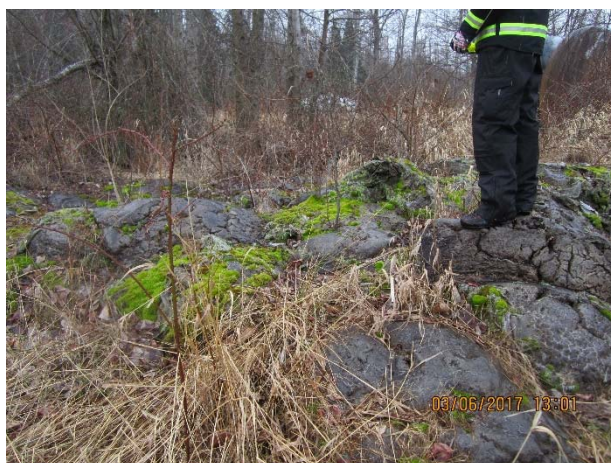
#92 North of Industrial Plant

Hardened rosin on the ground.
